# Optimized WESP and/or RTO System Design

## Refurbish Instead of Replace

# Refurbish and / or upgrade of existing WESP and/or RTOs

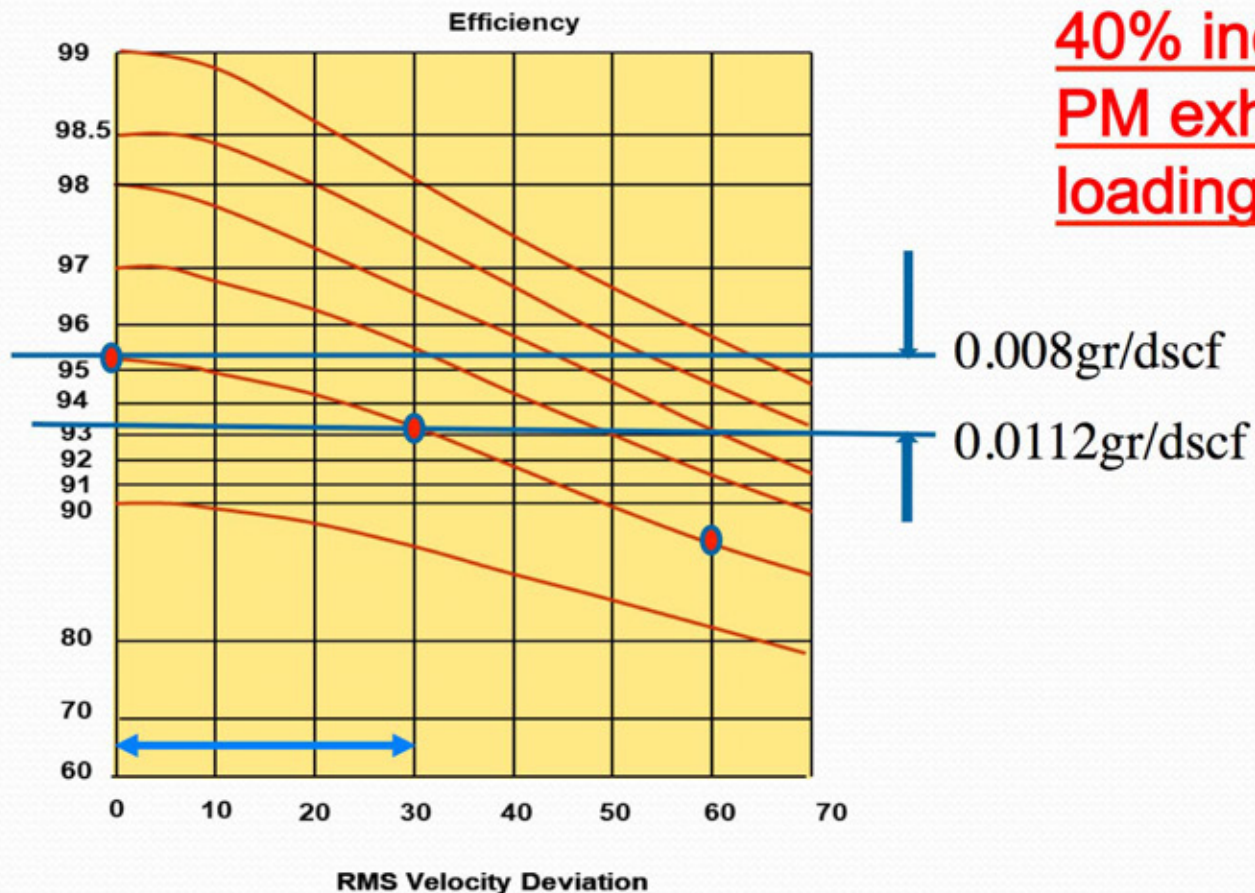
# WESP Uniform Air Flow, both up & down Flow, Key for Maximum Performance

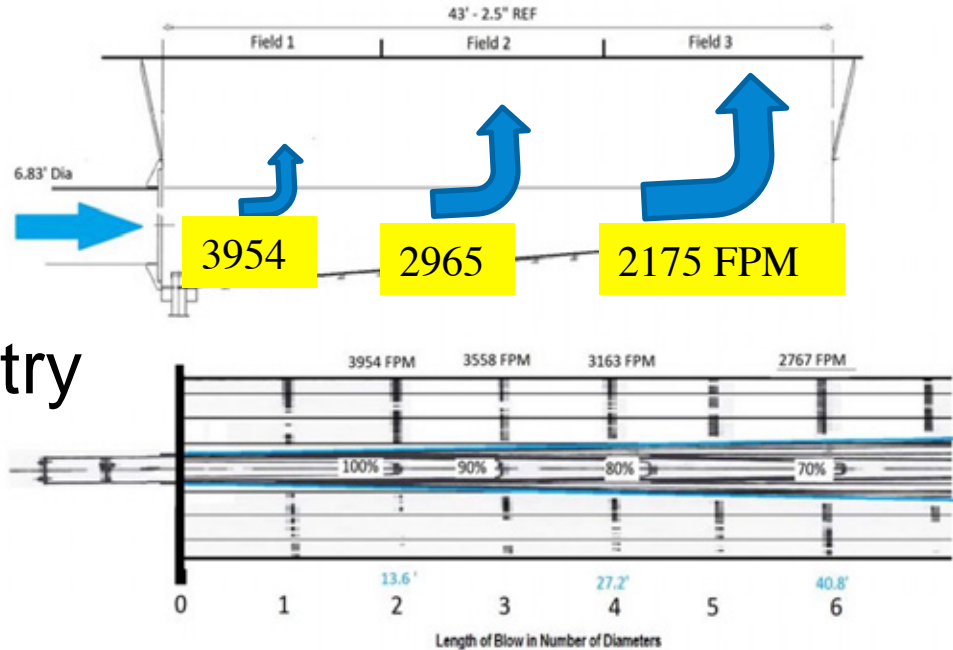
# Elevation view of WESP tube flow distribution

+/- 22% in tube flow =  
Reduced efficiency

High Entry  
Flow  
Velocity

WESP inlet plenum Velocity					
145,000	ACFM flow	WESP inlet duct dia 82"	distance from inlet duct (ft)	Air Velocity	
	Plenum inlet Velocity	6.83		3,954	FPM
	5 dia into plenum		34	2,965	FPM
	10 dia into plenum		68	2,175	FPM

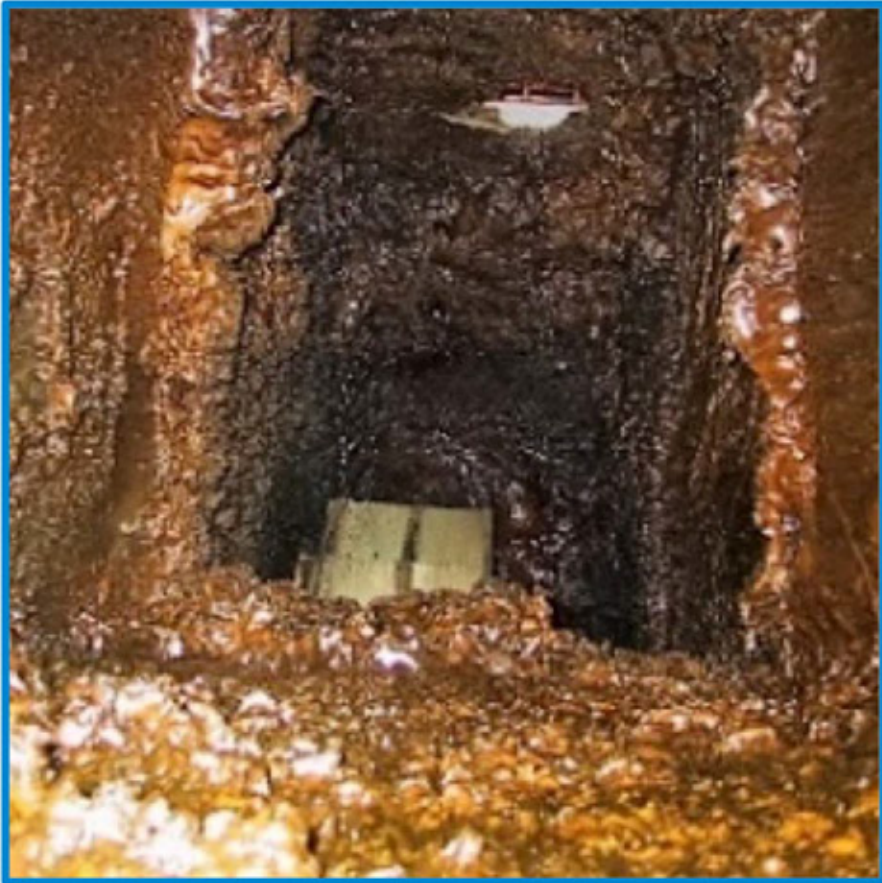
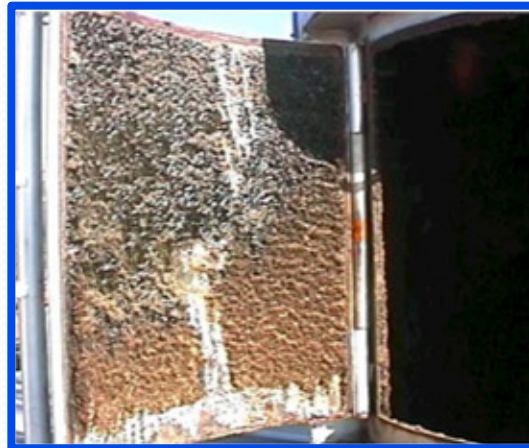
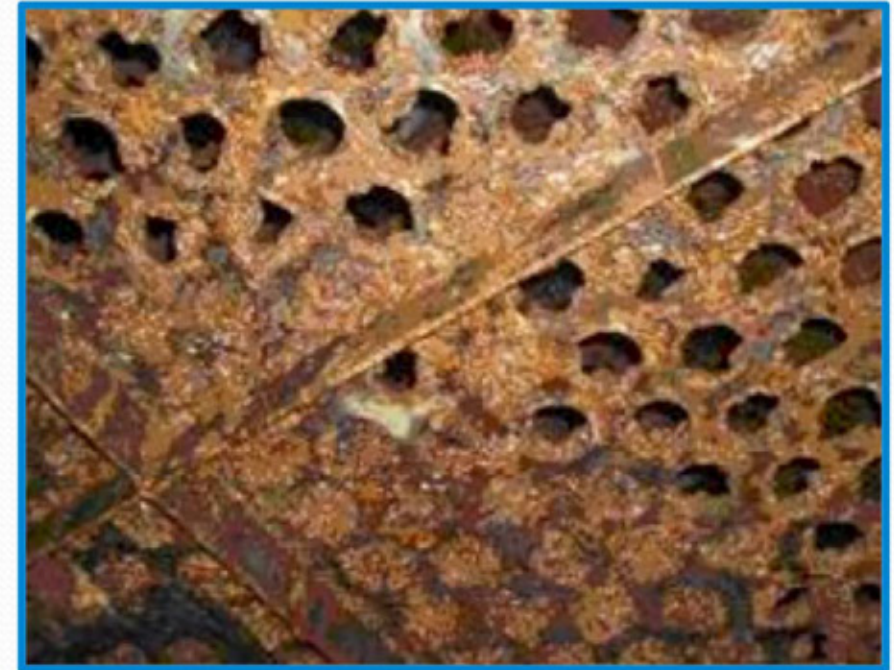
# Poor WESP performance results in condensable/PM build up

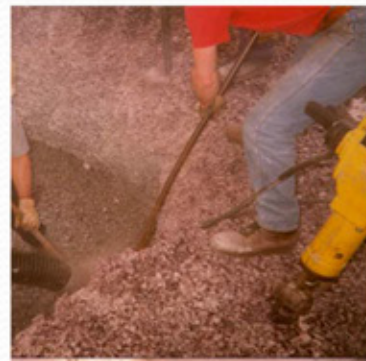
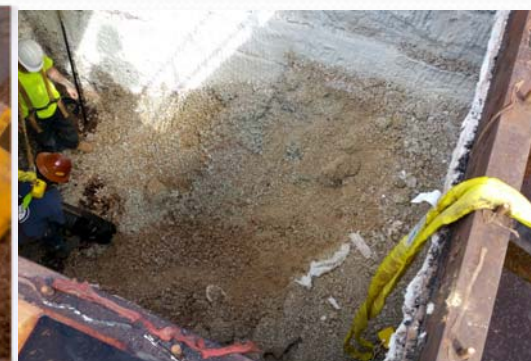
- Heat exchange media plugging, degradation and fusion due to fly ash, & potassium, etc.

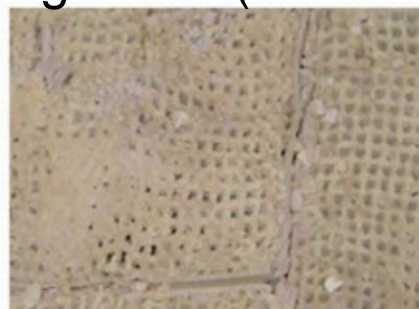
- Burner flame impingement (combustion chamber design)

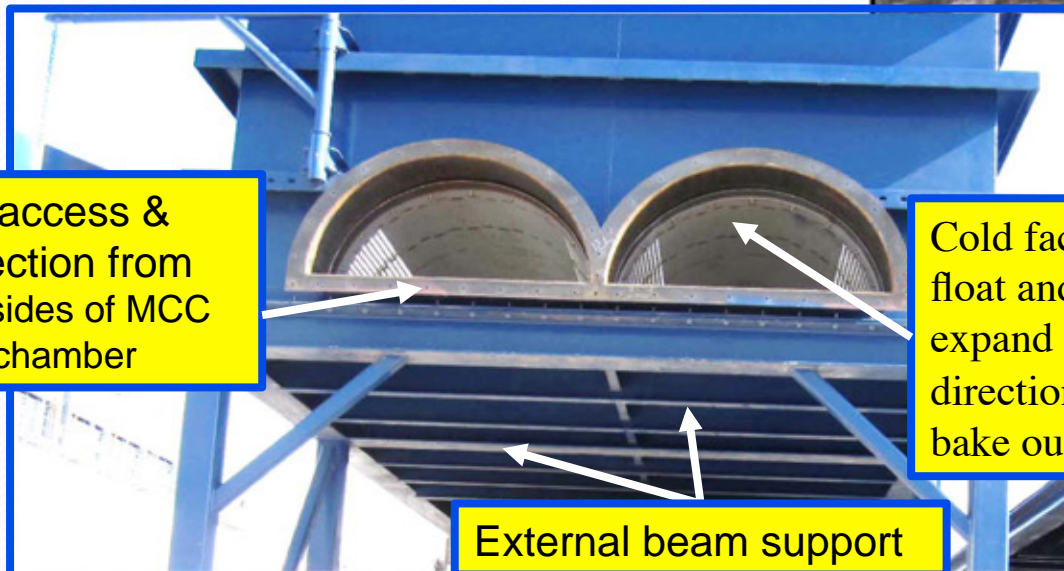
Localized hot spot due to poor flow distribution

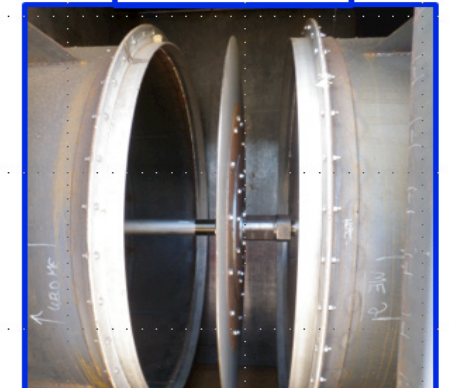
Spring Leaf Disk

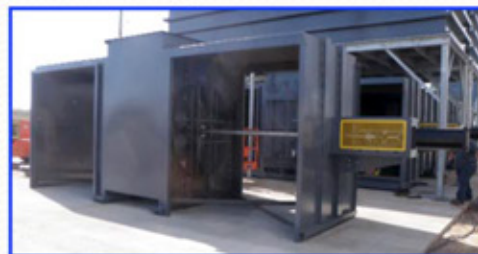
Slide poppet valve assembly under heat exchange chambers

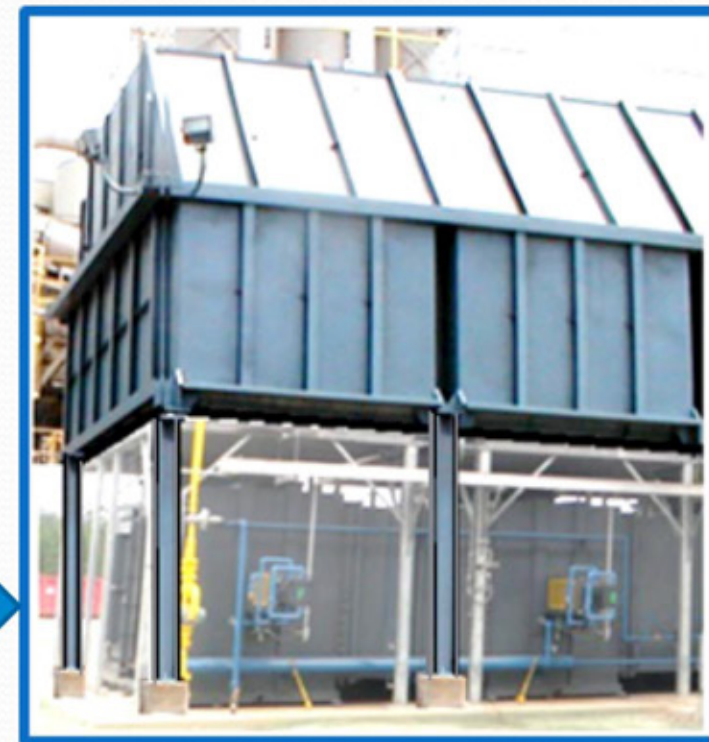
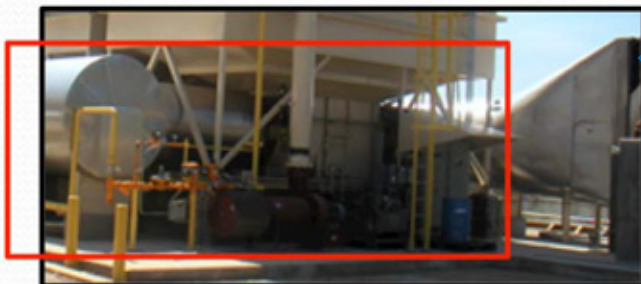
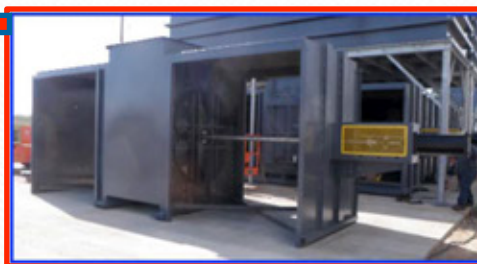
From this to this or this

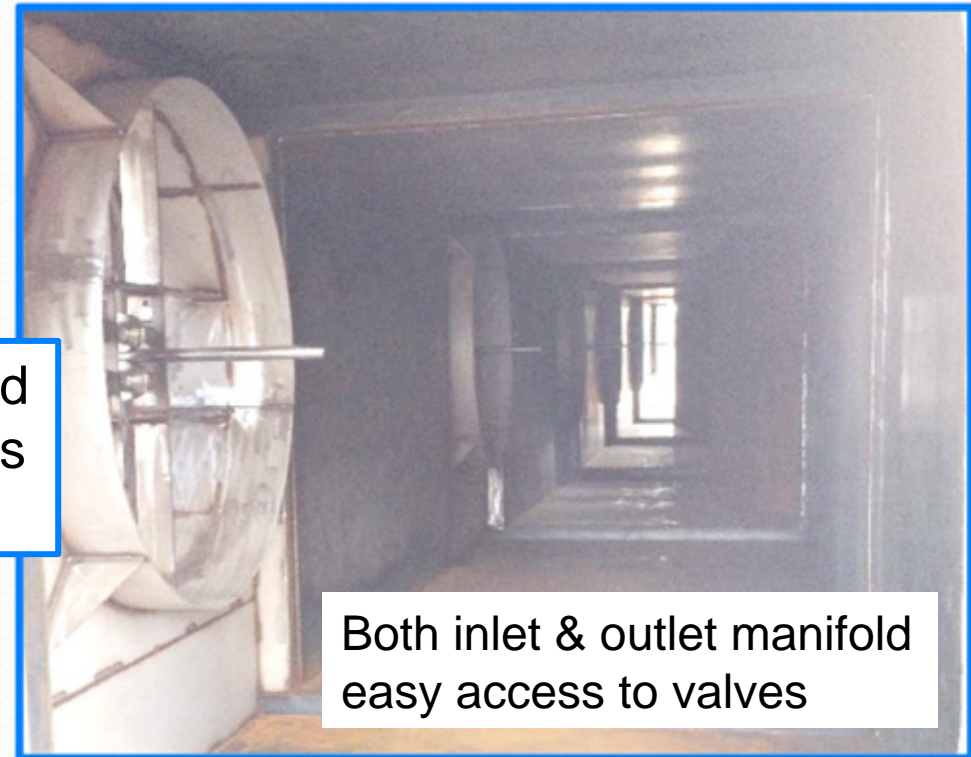
Hinged  
access  
door

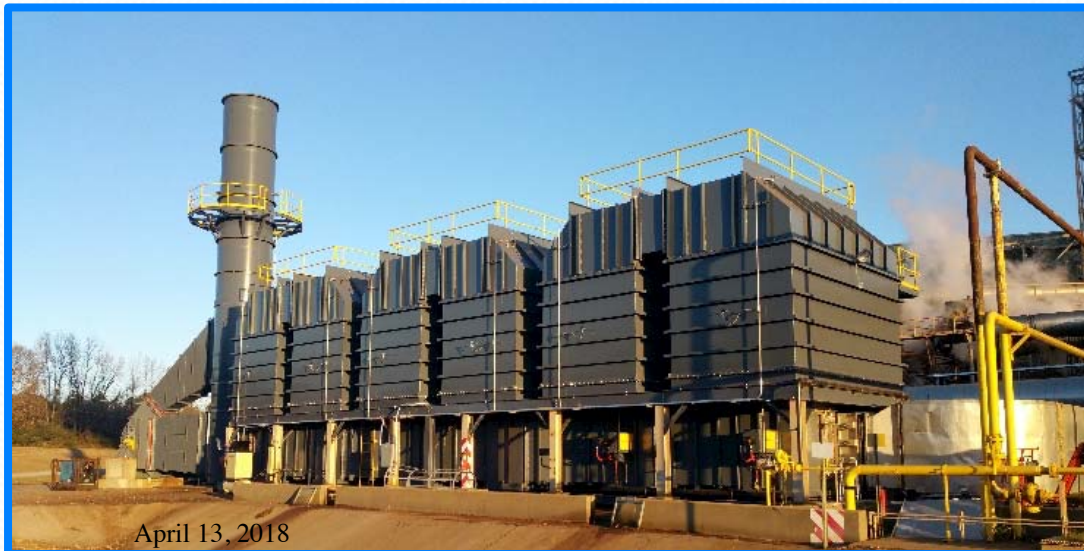
From this 7 chamber

Existing seven (7) chamber single combustion chamber RTO up  
graded to a six (6) chamber MCC (multi-combustion chamber) RTO

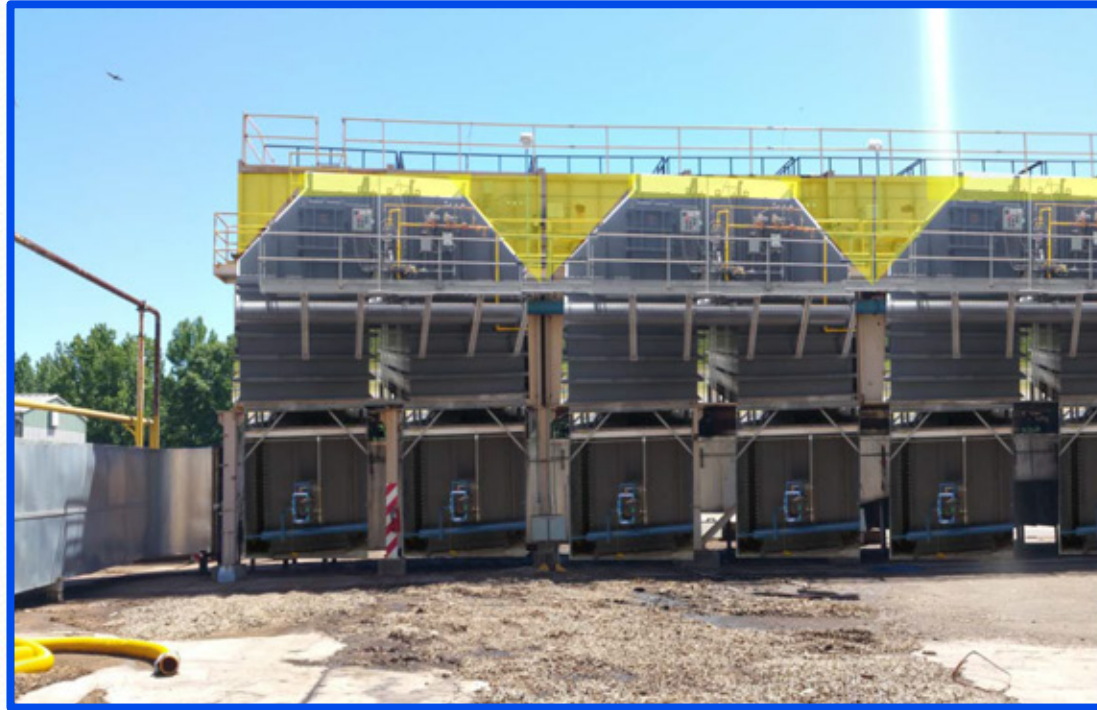
To this 6 chamber MCC

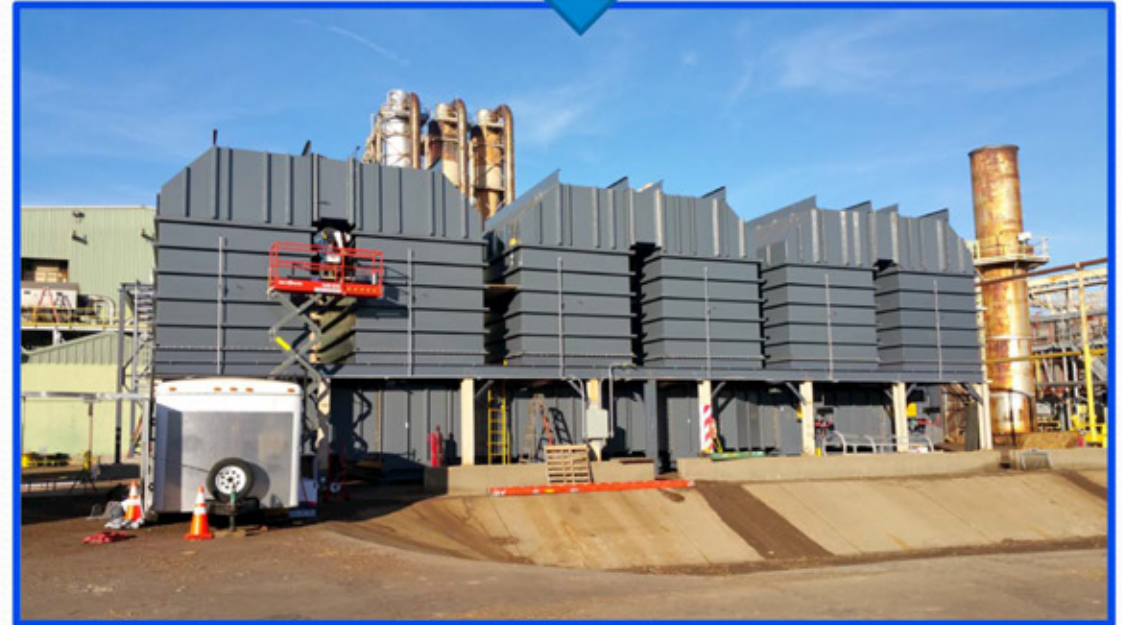
Combustion chamber  
converted to the MCC  
RTO Design

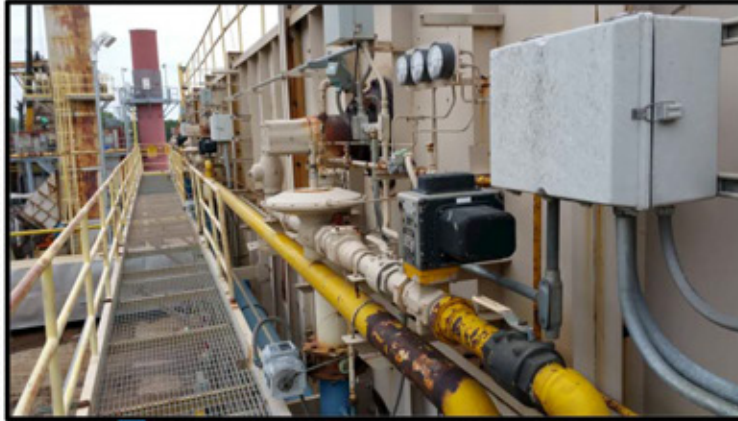
From this

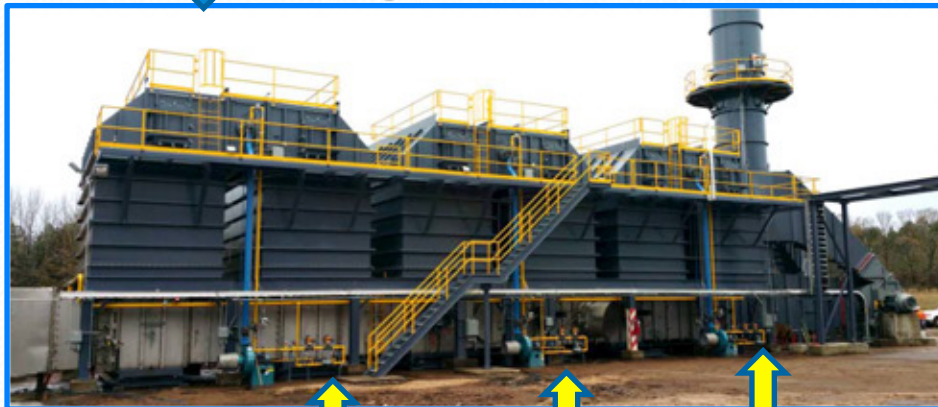
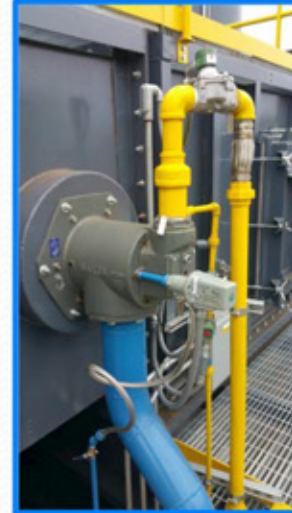
To this — with ground level controls

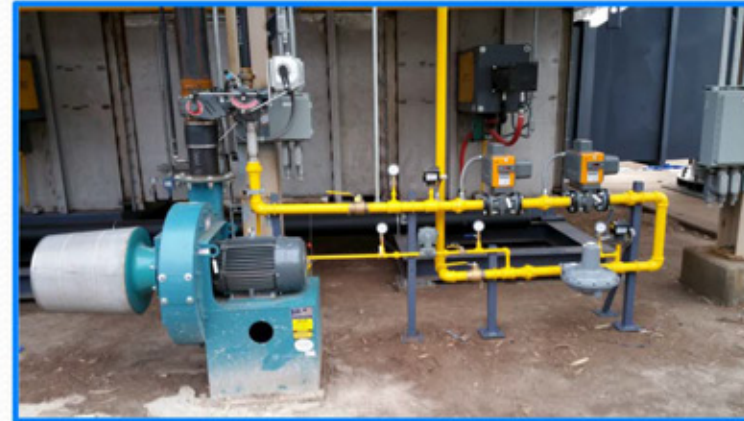
Individual  
combustion  
chamber control-  
uniform  
temperature with  
fuel savings
